CAYMAN ISLANDS SHIPPING REGISTRY

FLYER TO THE LARGE YACHT INDUSTRY

Fatal accident while launching Personal Water Craft.

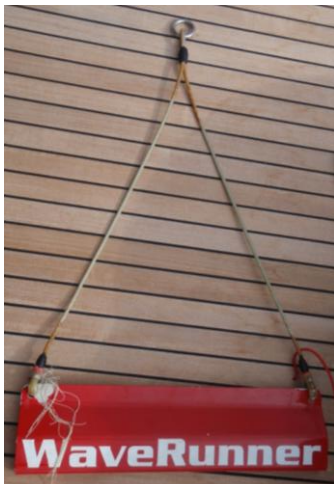
Sling and Spreader

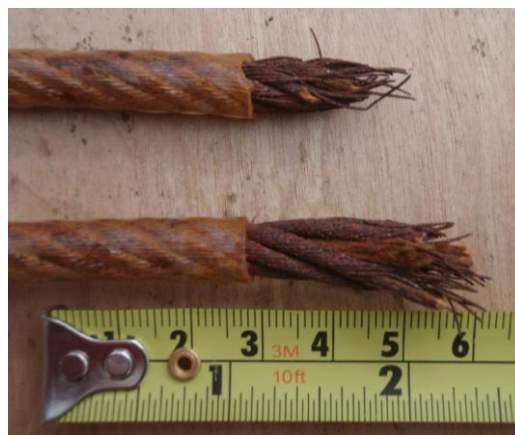
Upon inspection, the steel lifting slings in use were found to have failed in way of the crimped eye connection to the spreader beam. The slings were found to be heavily corroded and this corrosion had not been identified by the onboard maintenance and inspection regime. Further, the history and origin of the lifting sling was not readily apparent. It was stated that they were supplied with the PWC, but the model and manufacturer of the sling could not be identified and no manufacturer's documentation of certification could be located.

Failed slings

- Loose gear should be visually inspected before each use and be integrated into the onboard maintenance, inspection and testing regime.
- Examinations of lifting appliances and loose gear should be carried out by persons competent, by virtue of their knowledge and experience, to do so.

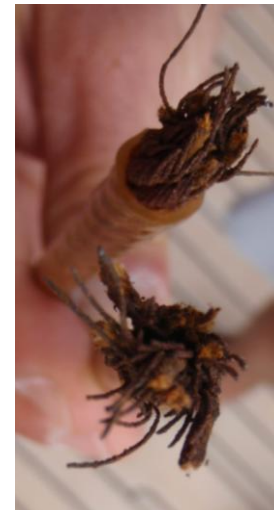
Corrosion of slings

- When visually inspecting loose gear, sufficient areas under tape and other “protective coverings” should be inspected such that the overall condition of the loose gear can be assessed.

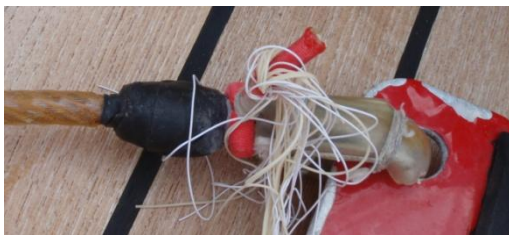
With “protective” tape

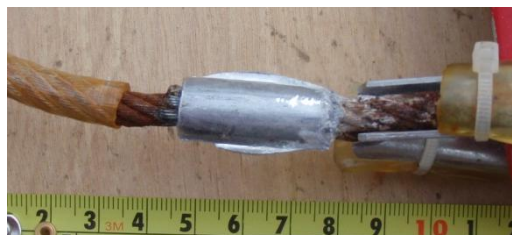
Tape removed
