CAYMAN ISLANDS SHIPPING REGISTRY

FLYER TO THE LARGE YACHT INDUSTRY

Fatal accident while launching Personal Water Craft.

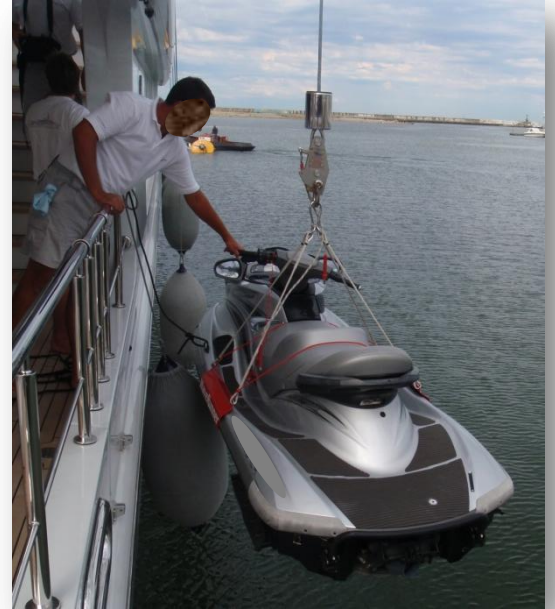
The deckhand was standing on the PWC and maintaining balance by holding the synthetic crane cable. With the PWC suspended approximately 2m above the water, lowering was resumed. Almost immediately, the inboard lifting slings failed and the PWC dropped to the water. Without the support of the PWC, the deckhand was unable to hold onto the crane cable and fell onto the PWC in the water. The deckhand landed face down on the PWC and, although remaining conscious throughout, sustained serious chest injuries. The deckhand was removed from the water and transferred to a local hospital. Sadly, he subsequently died from his injuries.

Upon inspection, the steel lifting slings in use were found to have failed in way of the crimped eye connection to the spreader beam. The slings were found to be heavily corroded and this corrosion had not been identified by the onboard maintenance and inspection regime. Further, the history and origin of the lifting sling was not readily apparent. It was stated that they were supplied with the PWC, but the model and manufacturer of the sling could not be identified and no manufacturer's documentation of certification could be located.
